Potential ground vibration threat to the Triangle Wastewater Treatment Plant and surrounding area

Date: Monday, June 28th, 2021 at 12:58 PM

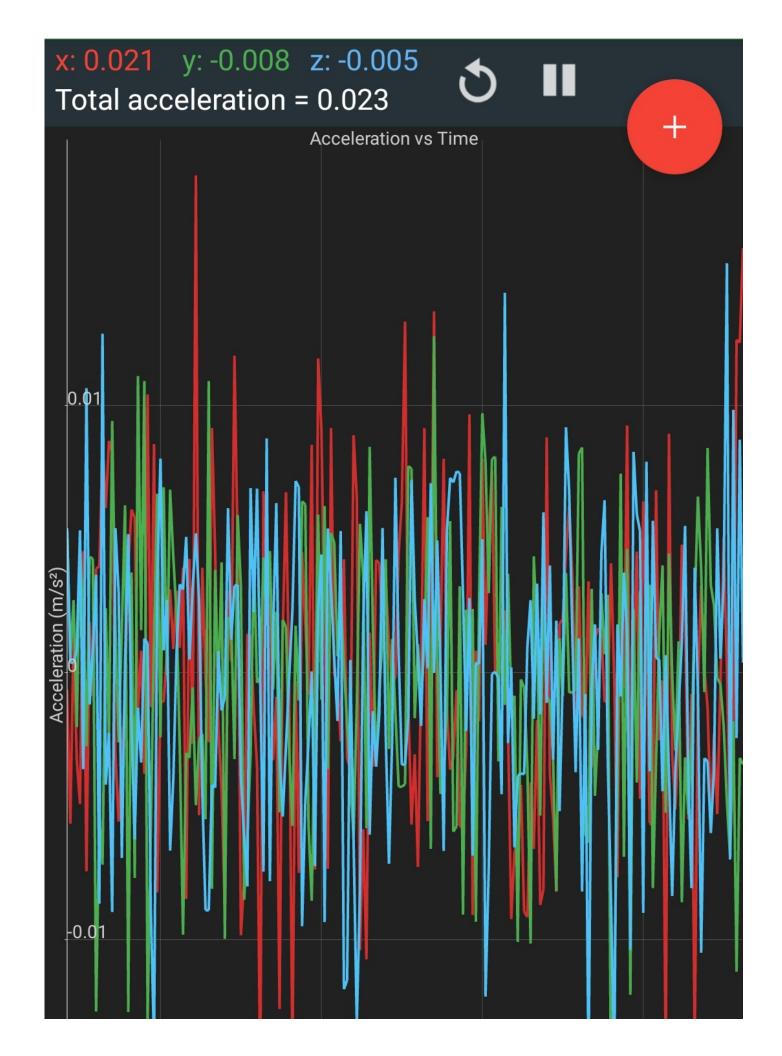
This is a graph from yesterday of the Falls Pointe Apartment complex readings and the site taken was at the end of the parking lot at a light post on a retaining wall at the end of the street so this rules out machinery causing it. You can see that the frequency is high but also varies. Red axis is North-South and that peak is maximal which suggests the location of the waves reaching 1-2m/s sq. Green is E-W. The peak from the ground retaining wall is much larger than from the 3rd floor apartment. I have taken a vibrational acceleration reading from the gate of the plant and it is comparable to the apartment reading so I am concerned that the plant is taking damage. The tenants at the FP complex also need to have this addressed because it is constant source of environmental noise irritation for them as the building shake is highest when the ground vibration is emitting strongly in the evening.

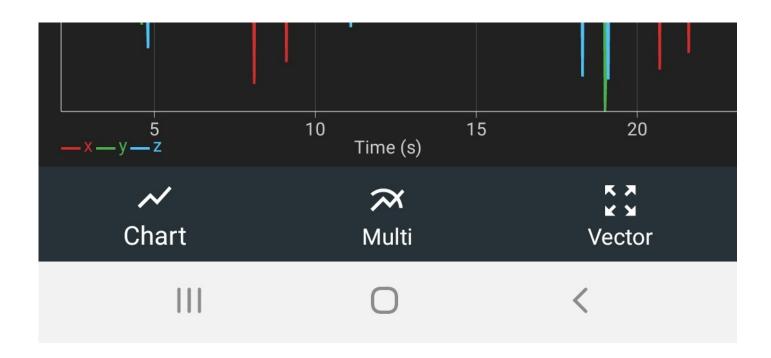
This accelerometer reading was taken from 300-400 Cascade Falls Lane parking lot edge from the concrete pillar base. Software used is Physics Toolbox by Vieyra Software version 2021.04.26.

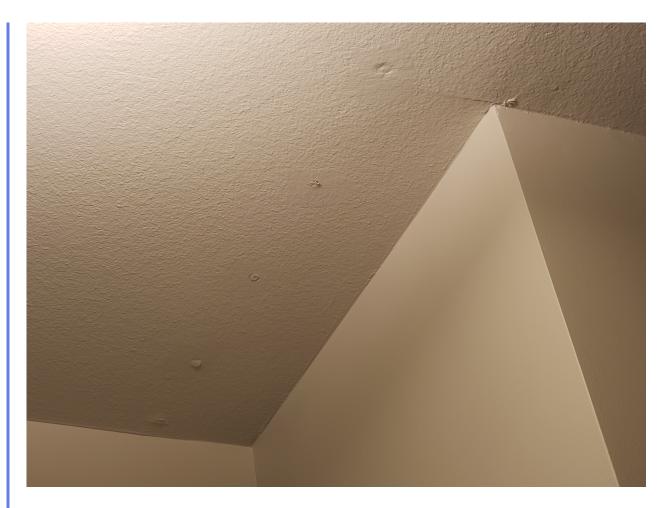
Ceiling nail heads pulling out

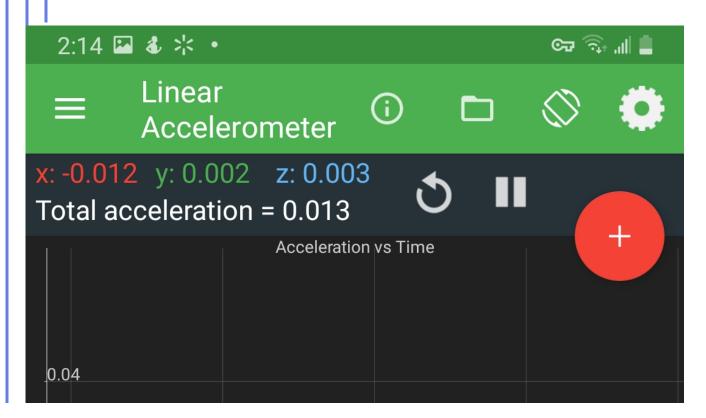
This is a photo from today 6/27/2021 at 2:14pm which shows a vibration at 96hz on an accelerometer. Red is North-South, Green is East-West, blue is vertical displacement.
